NIOSH
Fire Fighter Fatality Investigation
and Prevention Program

Residential Structure Fire Claims the Life of One Career Fire Fighter—Alabama

Fatality Assessment and Control Evaluation Investigative Report #F2000-26

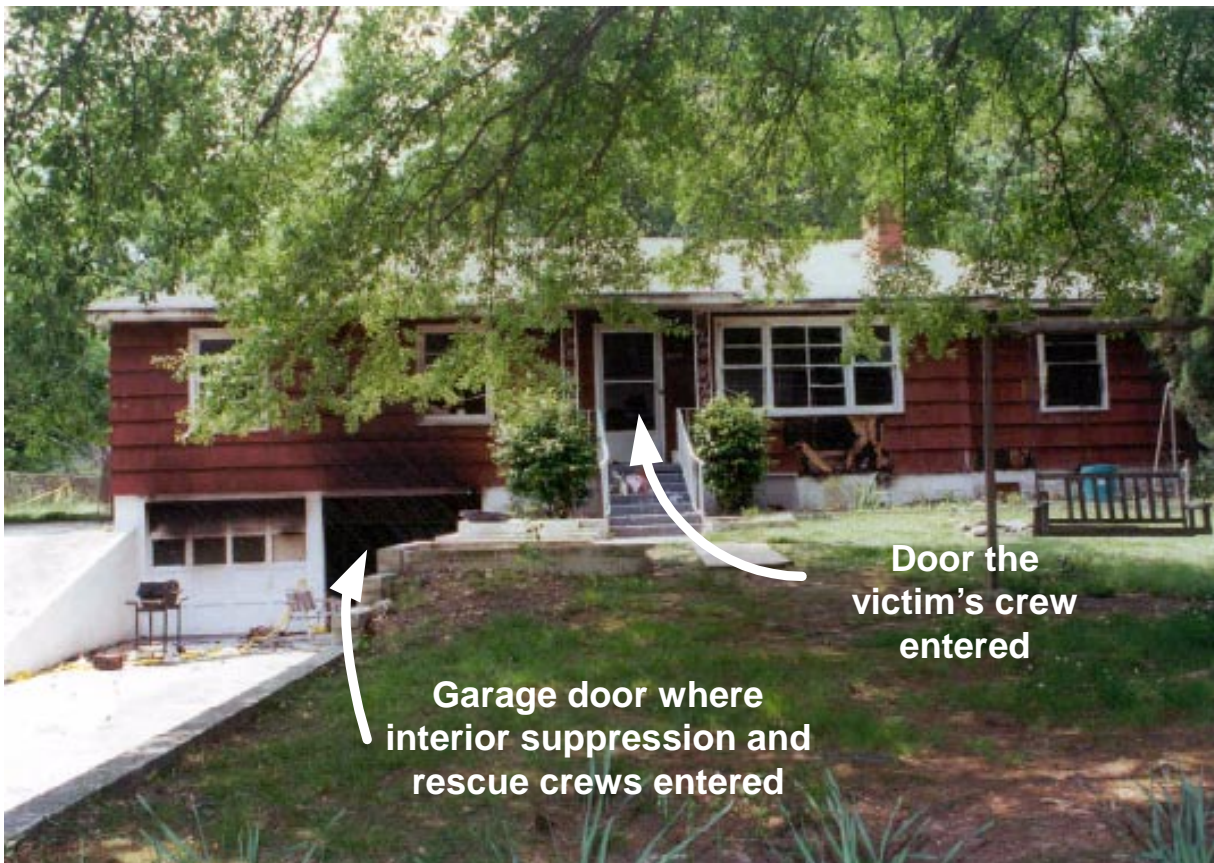
Photo 1. Points of Entry of Fireground Personnel for Fire Suppression and Rescue Crews

around of the structure, and confirmed to Central Dispatch that there was a working structure fire with thick, black smoke emitting from the garage/basement area (Photo 1). As Engine 1 was approaching the scene, the IC instructed the crew to stop and connect to the hydrant. Rescue 52 met up with Engine 1 at the hydrant and assisted them in making the connection. Engine 1 connected their supply line to the hydrant and proceeded to the scene as Rescue 52 finished making the hydrant connection.

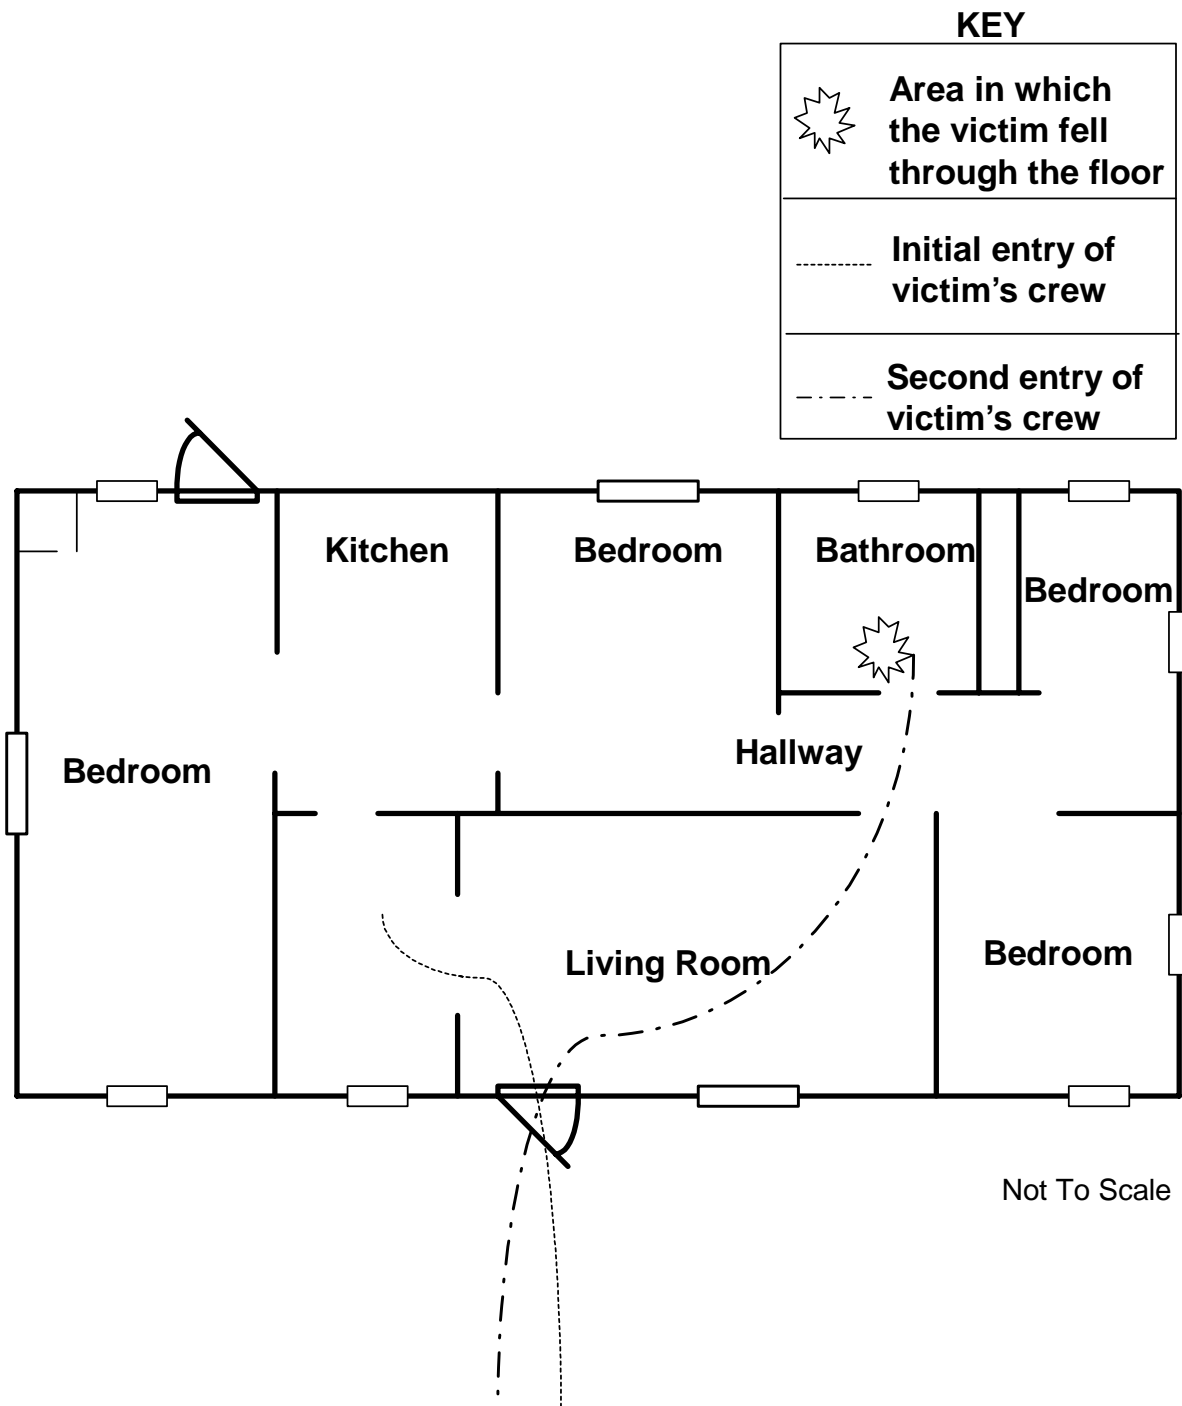
Figure 1. Aerial View of First Floor

Engine 2 arrived on the scene with a lieutenant, the engine operator/fire fighter (victim), and FF#2. The lieutenant from Engine 1 approached the IC to determine the location of the fire. The IC stated that the fire was in the basement. Rescue 52 (FF#3 and FF#4) arrived on the scene. The lieutenant from Engine 1 instructed FF#1 to pull a 1¾-inch handline off of Engine 1 and proceed with him into the structure through the garage/basement door (Figure 1).

(Figure 1). FF#3 proceeded into the garage/basement of the structure, entering through the garage door, and made his way into the basement about 10 feet and met up with the lieutenant from Engine 1 and FF#1. *Note: At this point, there was zero visibility in the garage/basement.* The lieutenant from Engine 1 and FF#1 and FF#3 attacked the fire with a 1¾-inch handline, but were forced to exit due to the extreme heat. After exiting the structure, FF#3 went to the rear of the structure to check for fire extension and for a better path to attack the fire.
